ESASI – FocusOn... Investigating Air Traffic Events

ATCU assistance to G-BXBU, stuck above cloud

Avions Mudry CAP 10B

Lower Colley Farm, Buckland St. Mary, Somerset - 12 August 2021

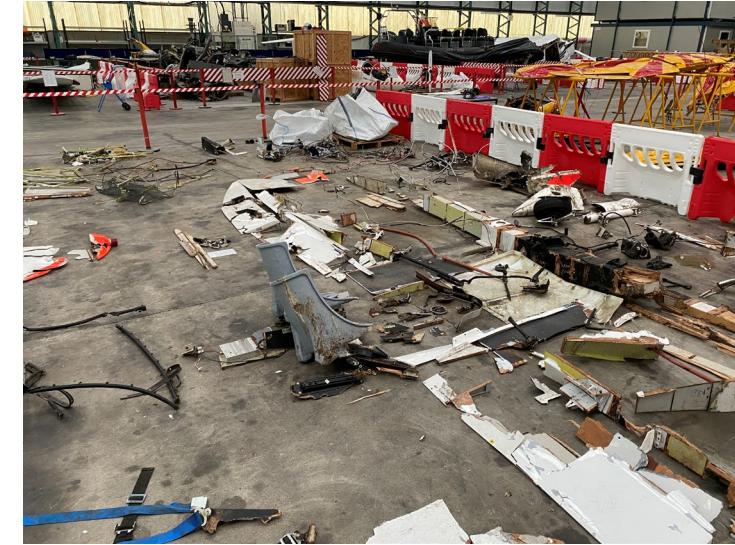
- Wreckage laid out to ensure no significant items missing
- The continuity of the flight controls were verified
- All damage was probably sustained during the impact
- No evidence was found of any anomalies that would have prevented normal operation
