ESASI – FocusOn... Investigating Air Traffic Events

ATCU assistance to G-BXBU, stuck above cloud

Avions Mudry CAP 10B

Lower Colley Farm, Buckland St. Mary, Somerset - 12 August 2021

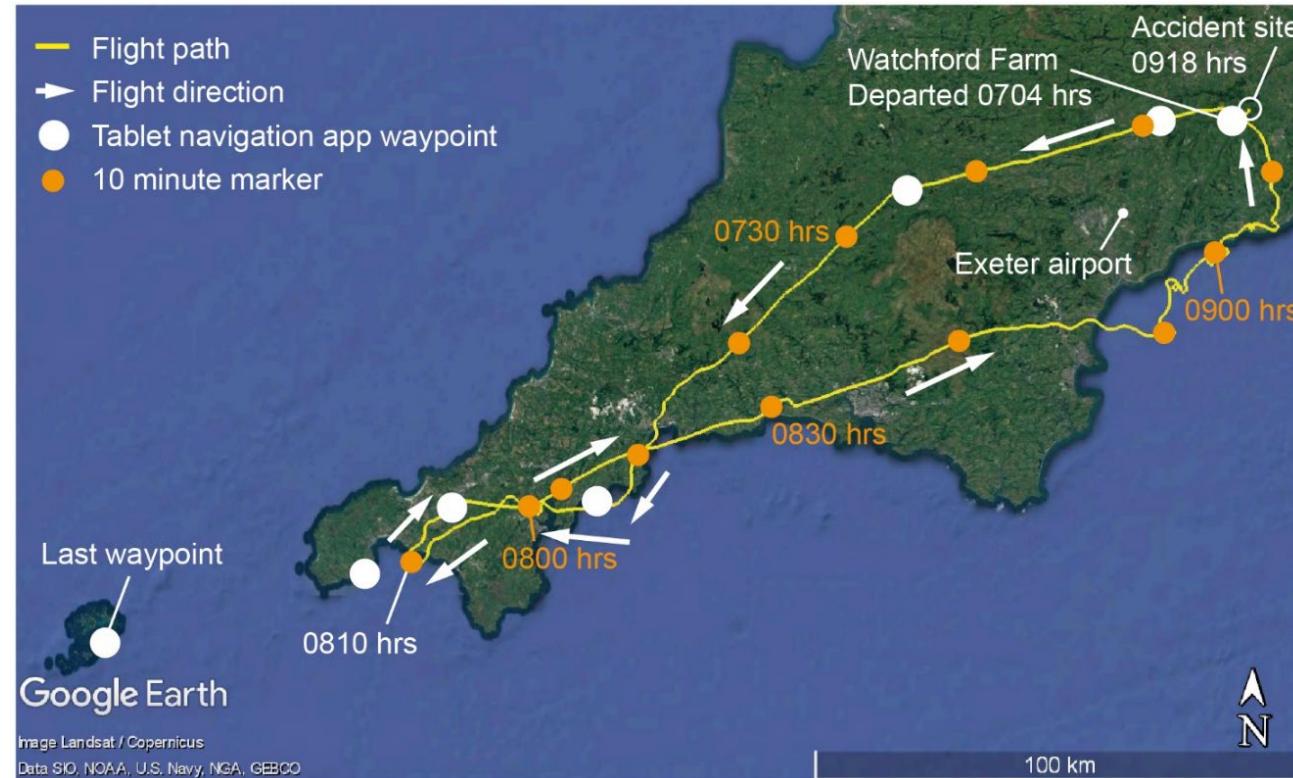
The flight

- Watchford Farm to Sicily Isles - Departure at 0704 hrs
- The pilot called declared an emergency at 0911 hrs on 121.5 MHz
 - Requested help and stated stuck above cloud
 - Needed to divert to somewhere where he could land
 - Confirmed the aircraft had fuel to fly for 90 minutes
 - Maintaining clear of cloud
- Simultaneous phone call from Exeter to D&D
- Exeter offered to take him
- D&D controller advised that Exeter were willing to accept him
- Descent began into cloud prior to contacting Exeter
- The pilot called Exeter Radar and restated his emergency status
- Exeter gave instructions for approach and landing
- Pilot was likely to have been flying in cloud, with high workload
- He probably became spatially disorientated and lost control of the aircraft at 0918 hrs

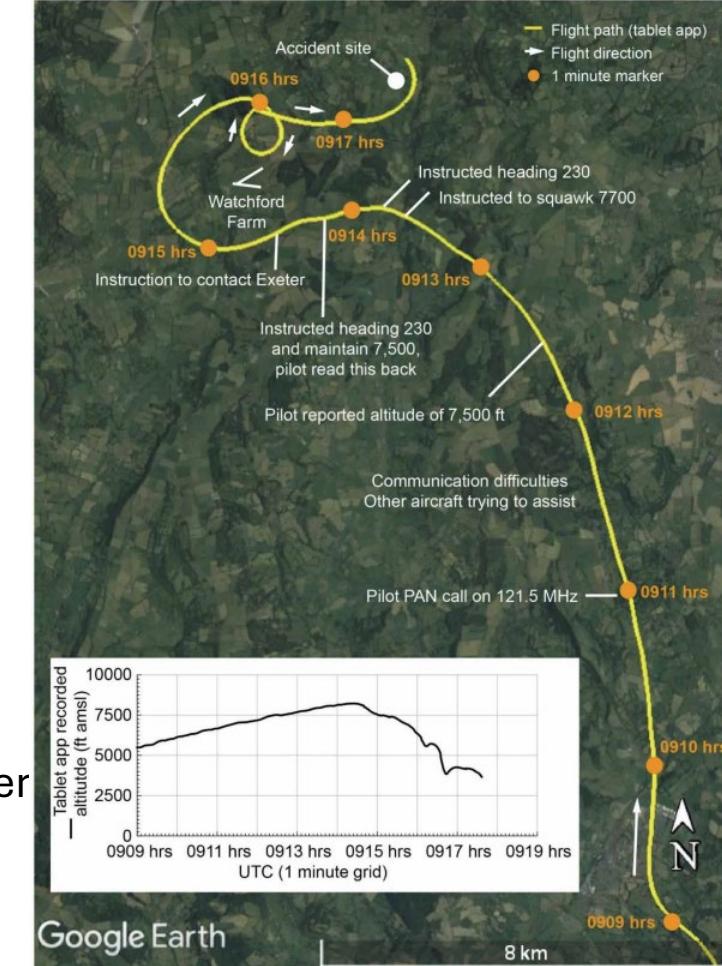
History of the flight

- Initial phone call between D&D and Exeter - an assistant at Exeter to a D&D support controller
 - Primary reason was to provide update on military jet with technical issue
 - Secondary discussion around G-BXBU and the pilot's intentions
 - Exeter assistant did not identify herself as such on the phone
- D&D stated G-BXBU was stuck above cloud and wanted to divert
- D&D interpreted that a qualified ATCO was offering help
- D&D did not check the weather conditions at Exeter before transferring the pilot
- Cloud base at Exeter was 500 ft
- No radar handover was completed between D&D and Exeter
- No further information on the status of the aircraft's emergency was requested by Exeter
- There was no active decision by a qualified person for G-BXBU to divert to Exeter
- Exeter issued Instrument Approach procedures to the pilot

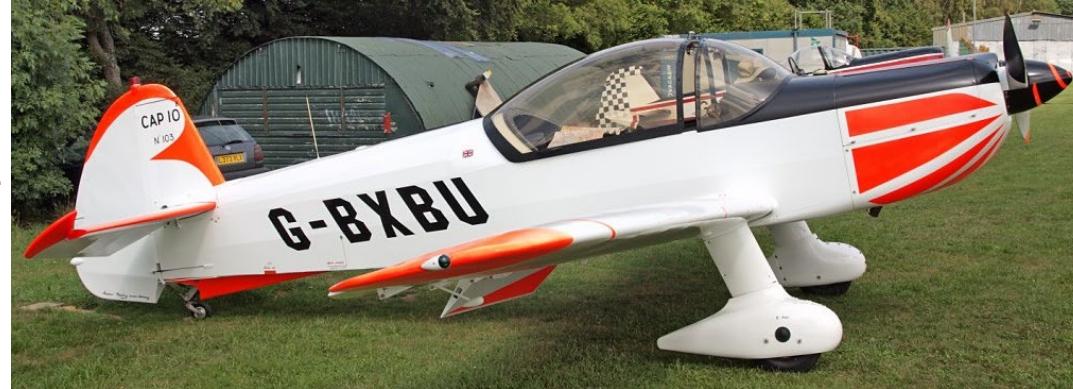
The aircraft

- Avions Mudry CAP 10B
- 2 seat side by side
- Wooden aerobatic aircraft
- Built in 1980, rebuilt in 1994
- 4250 airframe hours
- Cruise speed of 120-150 kt
- V_{ne} of 340 km/h (183 kt)
- Endurance of ~4 hours
